**A History of the Rowen Tract and its Cultural Resources,
Gwinnett County, Georgia**

Mark Reinberger and Dan Nadenicek

University of Georgia, College of Environment and Design (CE+D)

November 2021

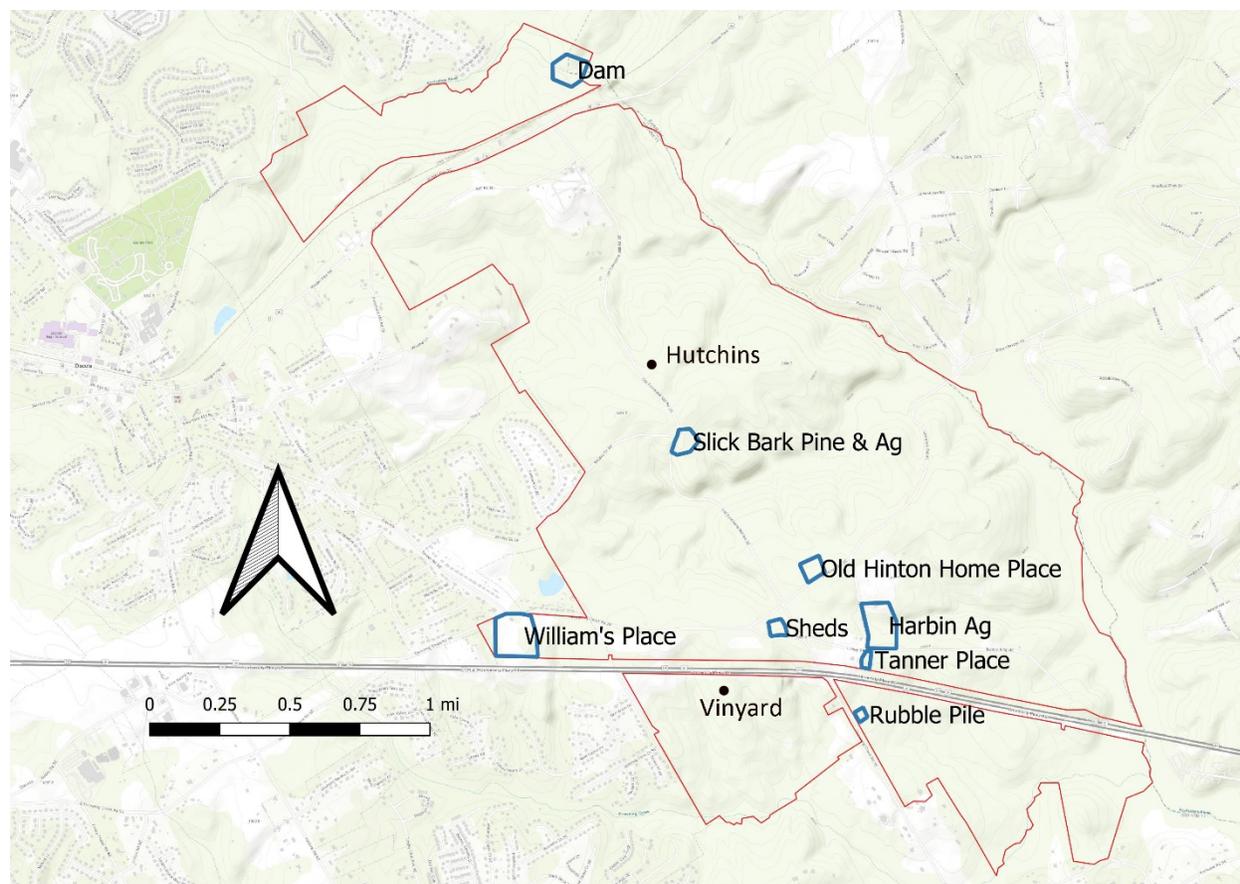
Figure 1: Overall Map of Rowen Tract with approximate location of major cultural sites.

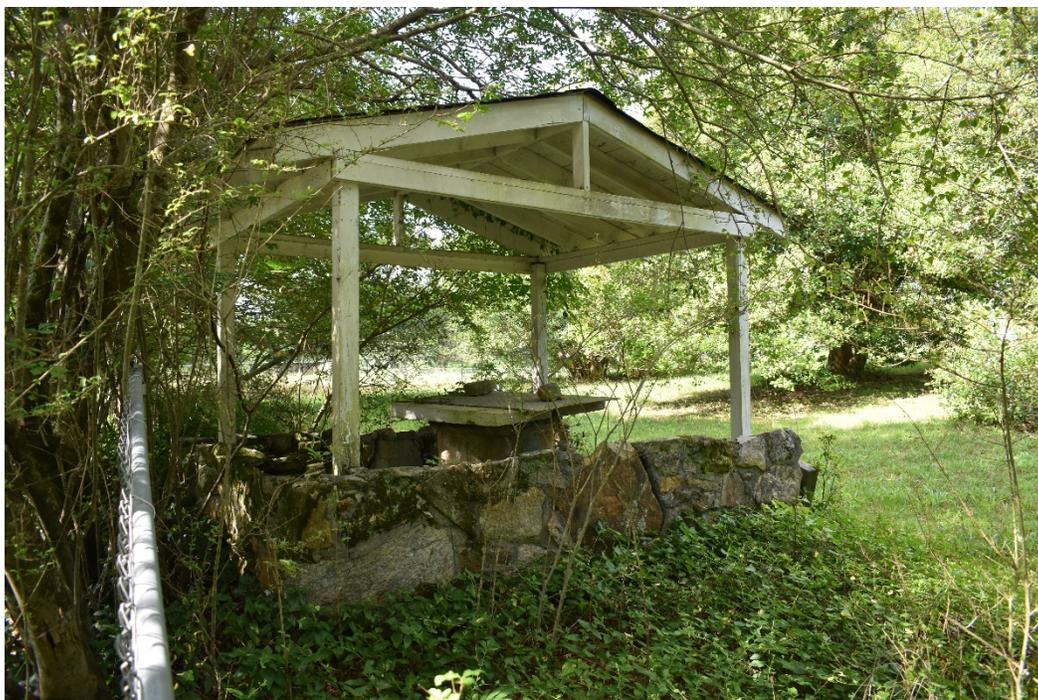
Figure 5: Well originally belonging to William T. Tanner House, Harbins Circle.

The well and its covering on Harbins Circle that originally belonged to the William T. Tanner House should be maintained as needed. Both structures are in fairly good condition now, but will need carpentry repair and painting from time to time to ensure longevity. The well

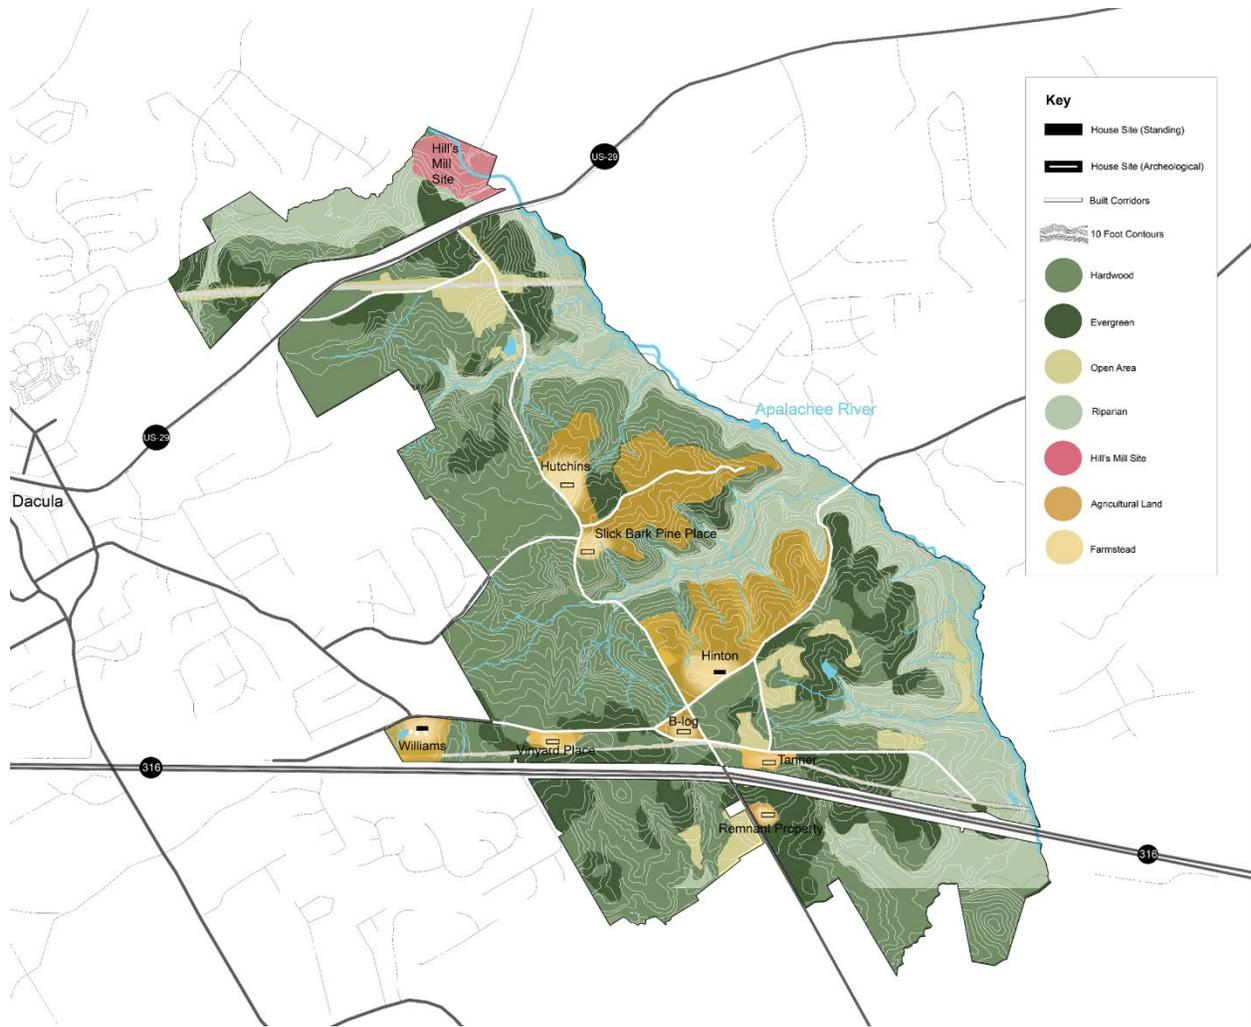
Fig. 7: Composed by Hannah Carroll

We then created two other maps to more clearly compare the open fields of 1944 (Figure 7) with the today's enclosed landscape consisting of planted pine trees (Figure 8). This comparison will assist Rowen in considering where historic vistas were located as well as the differences in the circulation experiences of the past as compared to today.

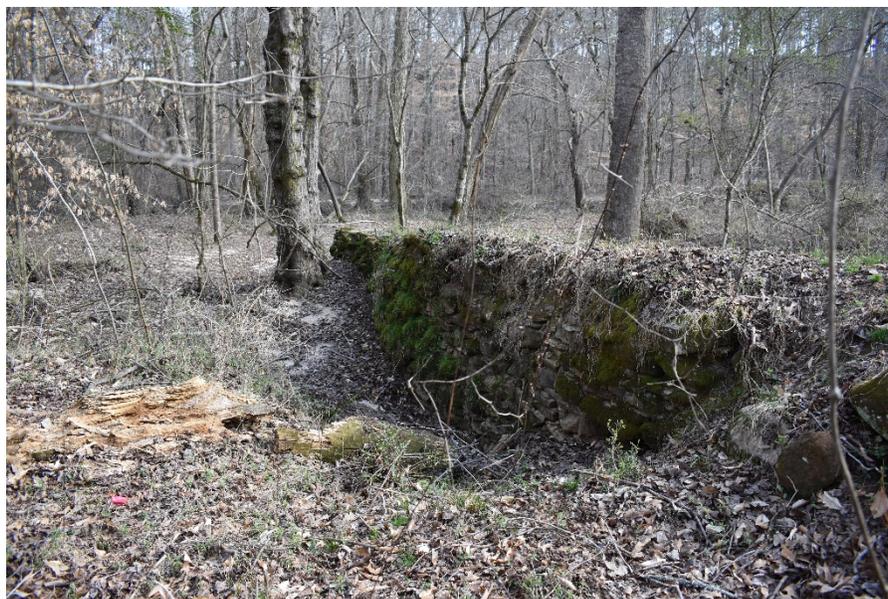
spot of the mill structure along the dam is unclear. (Fig. 9) Hill ran the mill until 1844 when he sold it to Lovick Betts of Jackson County. He sold the mill land in 1856 to Sterling Clark but kept the water privileges. Immediately after the Civil War, Clark and Betts sold both to Dr. Samuel H. Freeman, whose father ran the mill, sometimes hiring Hill's sons to help him. The road to the mill from the south became known as Old Freeman's Mill Road. (Confusingly, another branch of the Freeman family also owned a mill on the Alcovy River, so the county had two Freeman's mills.) The mill appears in an 1880 economic census, listed as a two-tub grist mill with 12 feet of head power. A tub mill was a fairly simple mill type with a horizontally-mounted wooden wheel contained in a "tub," a type used often by Scots-Irish settlers on the frontier where water levels were low. It ran into the early twentieth century and had a small community around it.³⁷

Figure 9: Hill's/Freeman's Mill Dam, circa 1820

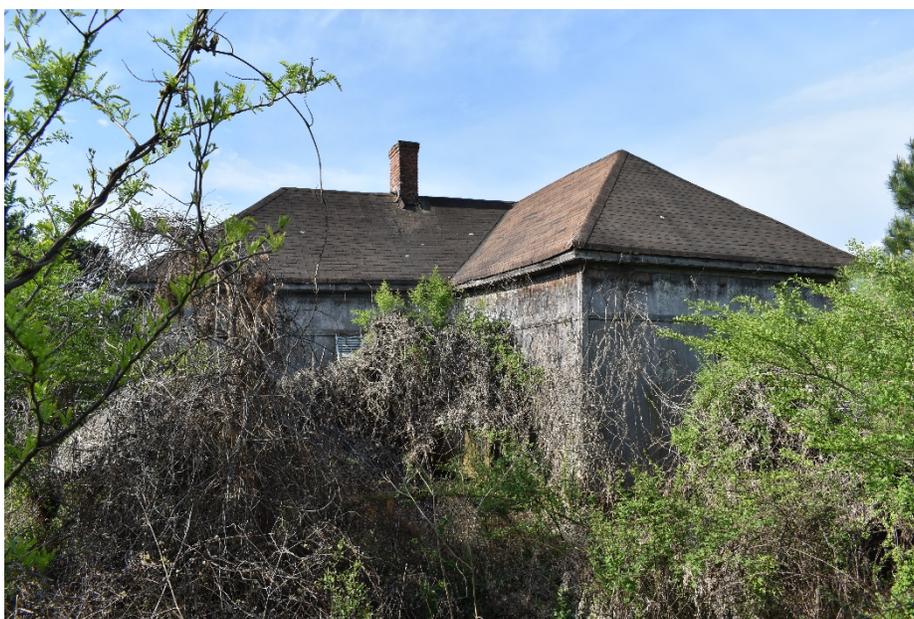
The house that William T. Tanner built for a sharecropper stands forlorn in a patch of scrub forest and field growth near the subdivision on Turkey's Crossing. (Fig. 12) It has three nearly square rooms in an ell configuration, two heated by a shared chimney block with a fireplace on each side (see Appendix E). The remaining room has no fireplace but may have had a hanging chimney, suggesting a stove in a kitchen. The original orientation was probably towards the west, where an apparent front door gives access to the one heated room, the kitchen standing to the left. Brick foundation piers hold the structure about two feet above the ground.

Plywood now covers the exterior walls but the original five-inch-wide clapboards can still be seen. Walls are framed with 2 by 4s. Joists are 2 x 8s, spaced two feet on-center. Rafters are 3 x 4s, also spaced two feet on-center, with original 1 x 6 spaced lath now covered with plywood. Interior walls and ceilings now also have plywood coverings but originally had tongue-and-grooved boards. Floors are 1 x 5 boards. Windows appear original: double-hung with four-over-four sash; as do the two-panel wood doors with good hardware. Newer partitions in one of the rooms suggested an abortive attempt to create a bathroom or kitchenette. A well-built agricultural outbuilding, of about the same date and construction type as the house, stands to the northeast of the house.

Figure 12: Tanner Tenant House, Turkey's Crossing, circa 1900

The house's modesty indicates its origin as a tenant dwelling, though it had fairly high ceilings and fairly high-quality original finishes and trim. Its remembered date of circa 1900 is confirmed by its style, framing (circular sawn), and wire nails. The changes made in 1978 include plywood walls inside and the creation of a small room for a bathroom. The structure

retains little integrity and is in fairly ruinous condition. There would be little to salvage or gain from its repair and reuse, so demolition seems the most obvious recommendation.

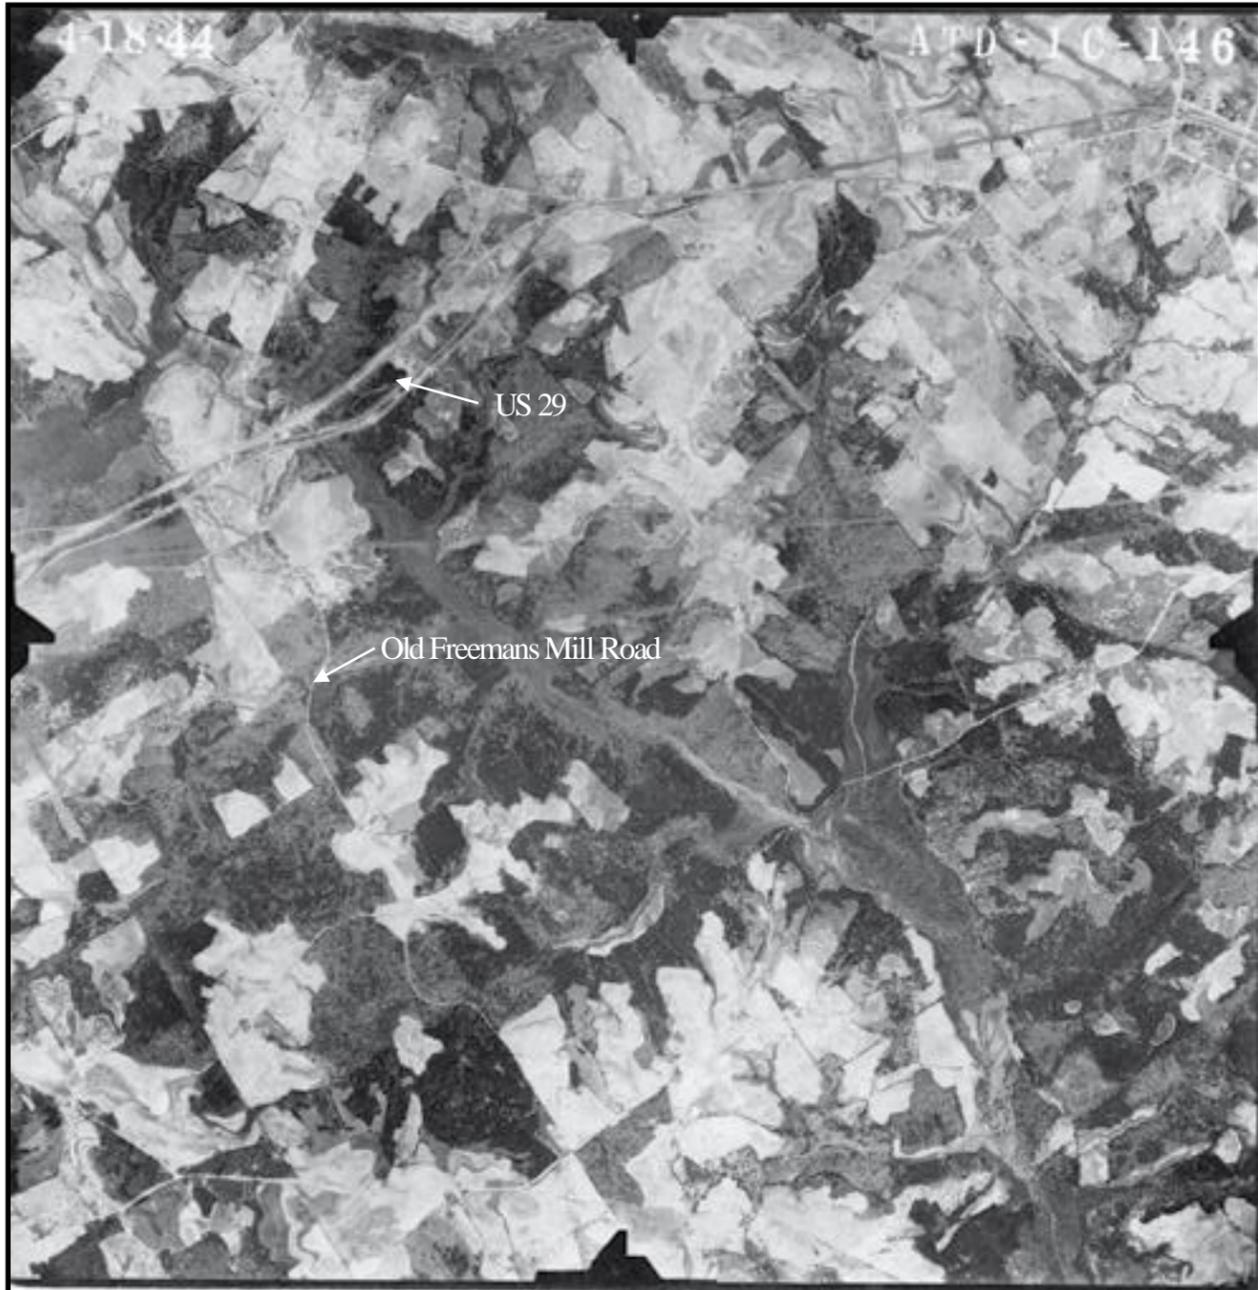
1944 – Historic Rowen Aerial (Base for Analysis)

This was the base map used to create the historic Rowen map analysis from 1944. This acted as a great reference for the team because it revealed the historic land use of the properties located on the site. To the north you can see US highway 29, then going south, Old Freemans Road, and at the bottom of the photo, the characteristic triangle created by Harbins Circle, Old Freemans Mill Road, Lawrence Road, and Turkey Crossing. Roadways and natural features were aligned in AutoCAD using survey data provided by HGOR which is shown in the lower right photo.

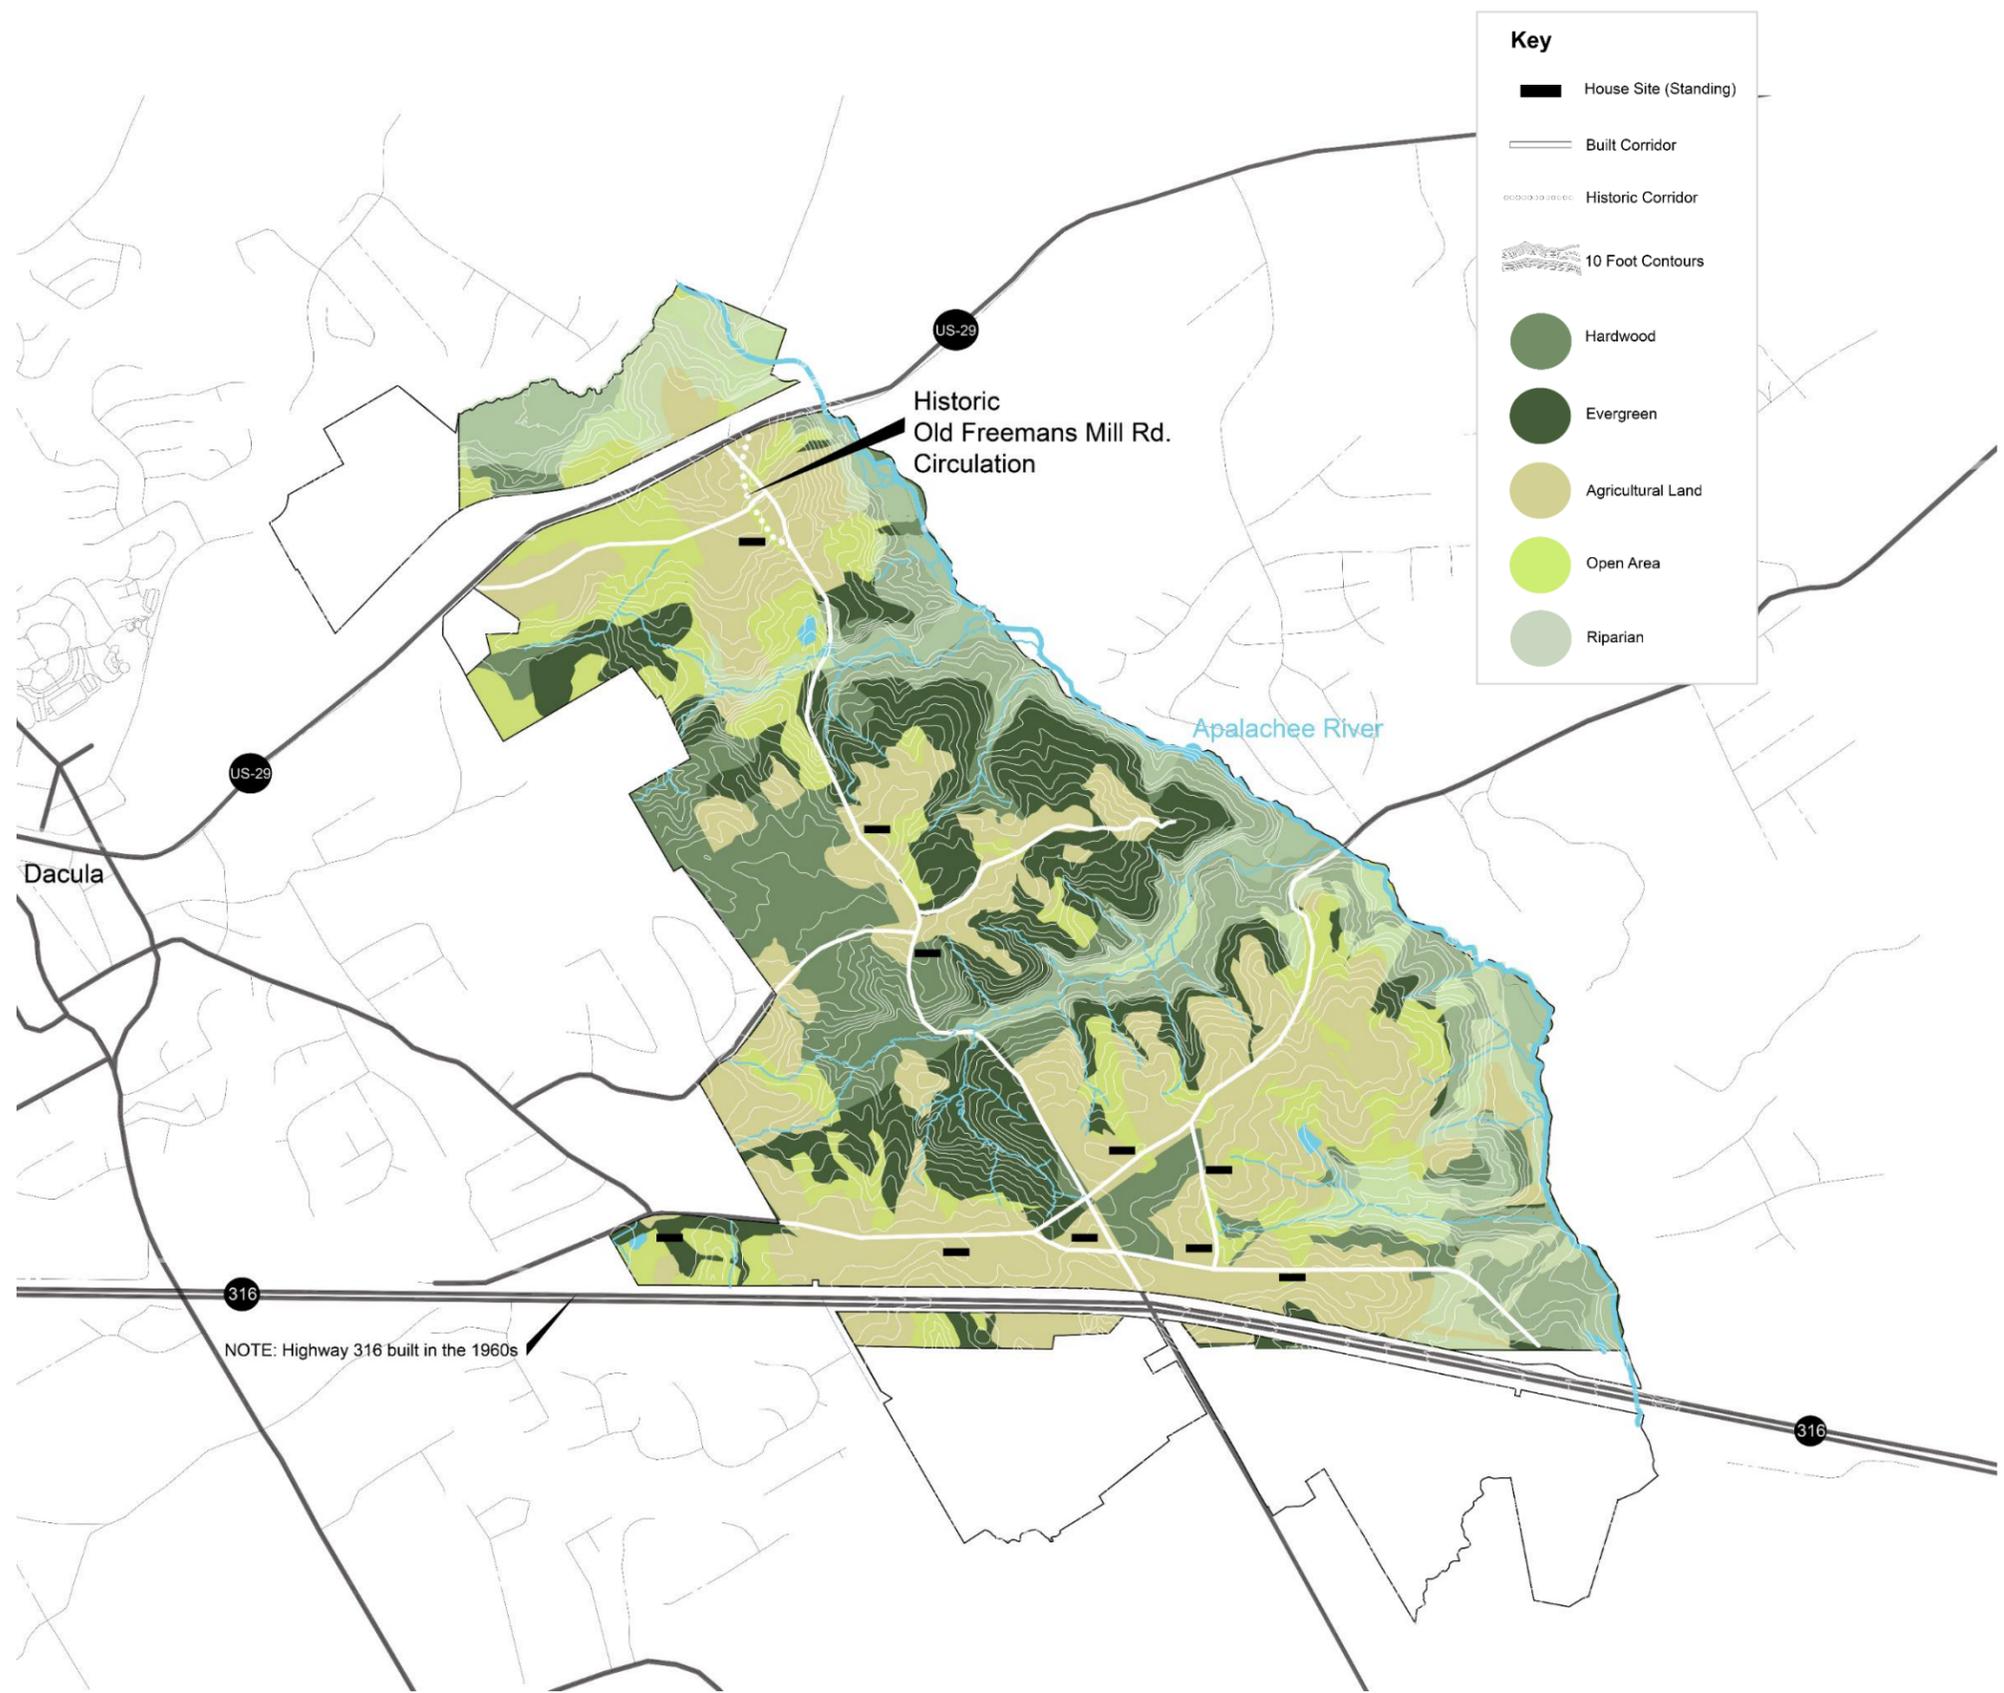
1944 – Historic Rowen Map Analysis
 This map was created in photoshop using an aerial from 1944 as a base. It out characterization of the landscape, this and the aerial were key is deciphering the history of the land. Large portions of the land were dedicated agricultural land or open area. Much of the riparian zone along the Apalachee river was maintained, especially north of Brown Bridge Road.

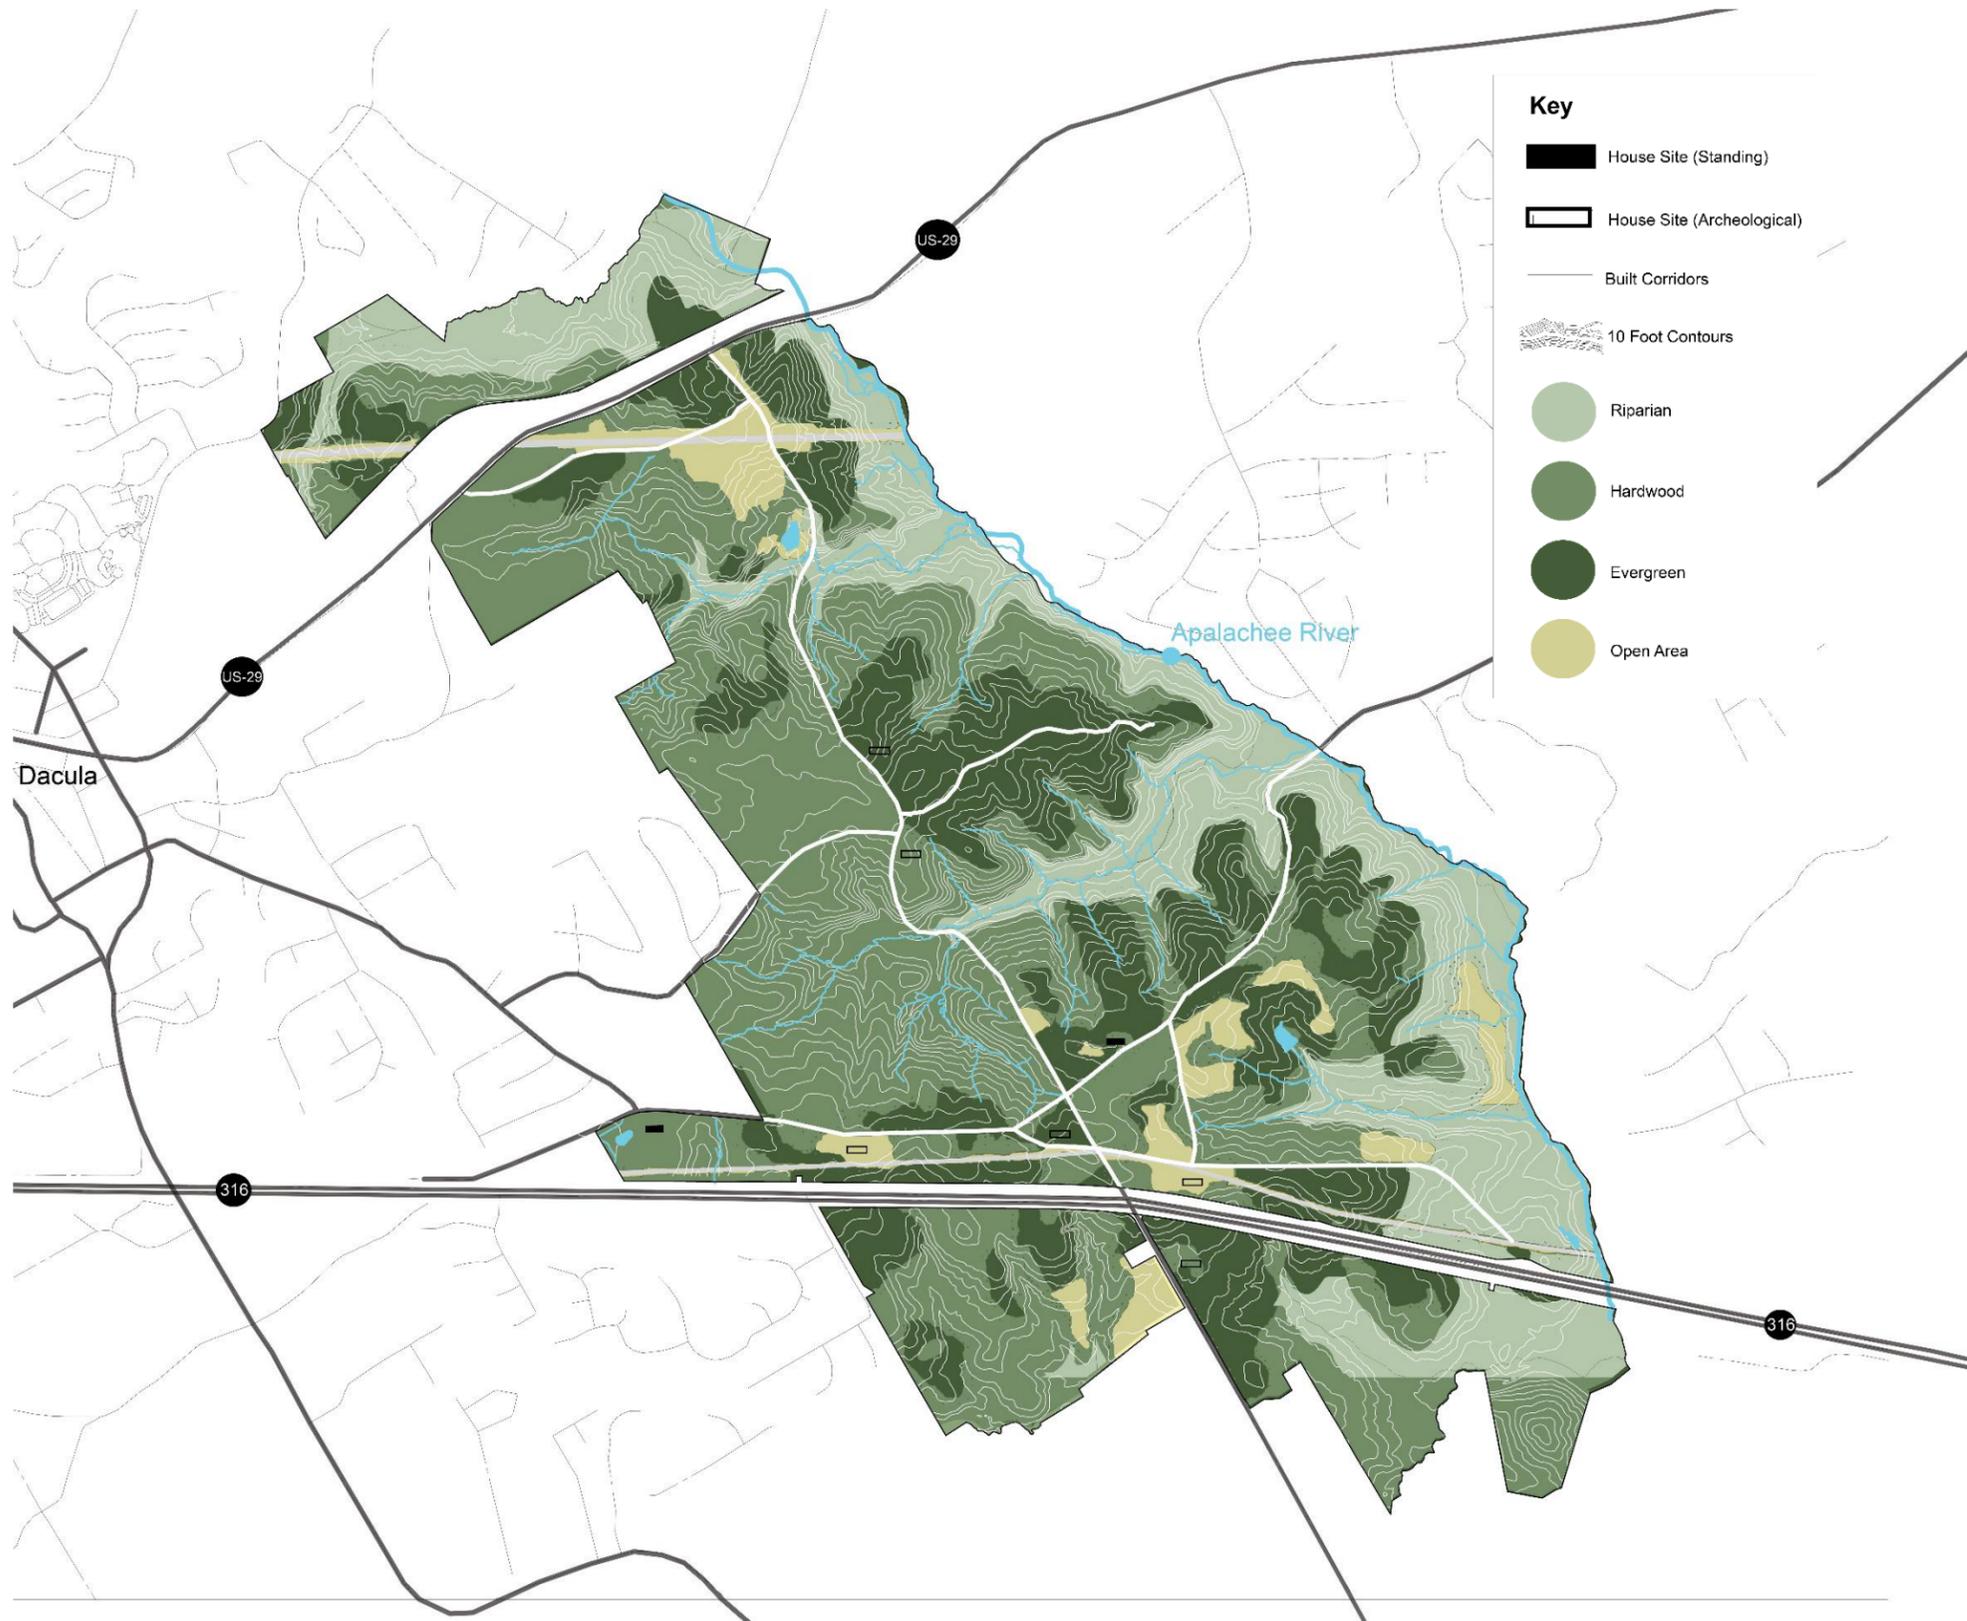
2019 - Existing Rowen Map Analysis

This map was created with the use of a photoshop file from HGOR. It has been adjusted to show current land condition (riparian, hardwood forest, evergreen forest, and open area). This map also shows both standing homesites and archeological homesites.

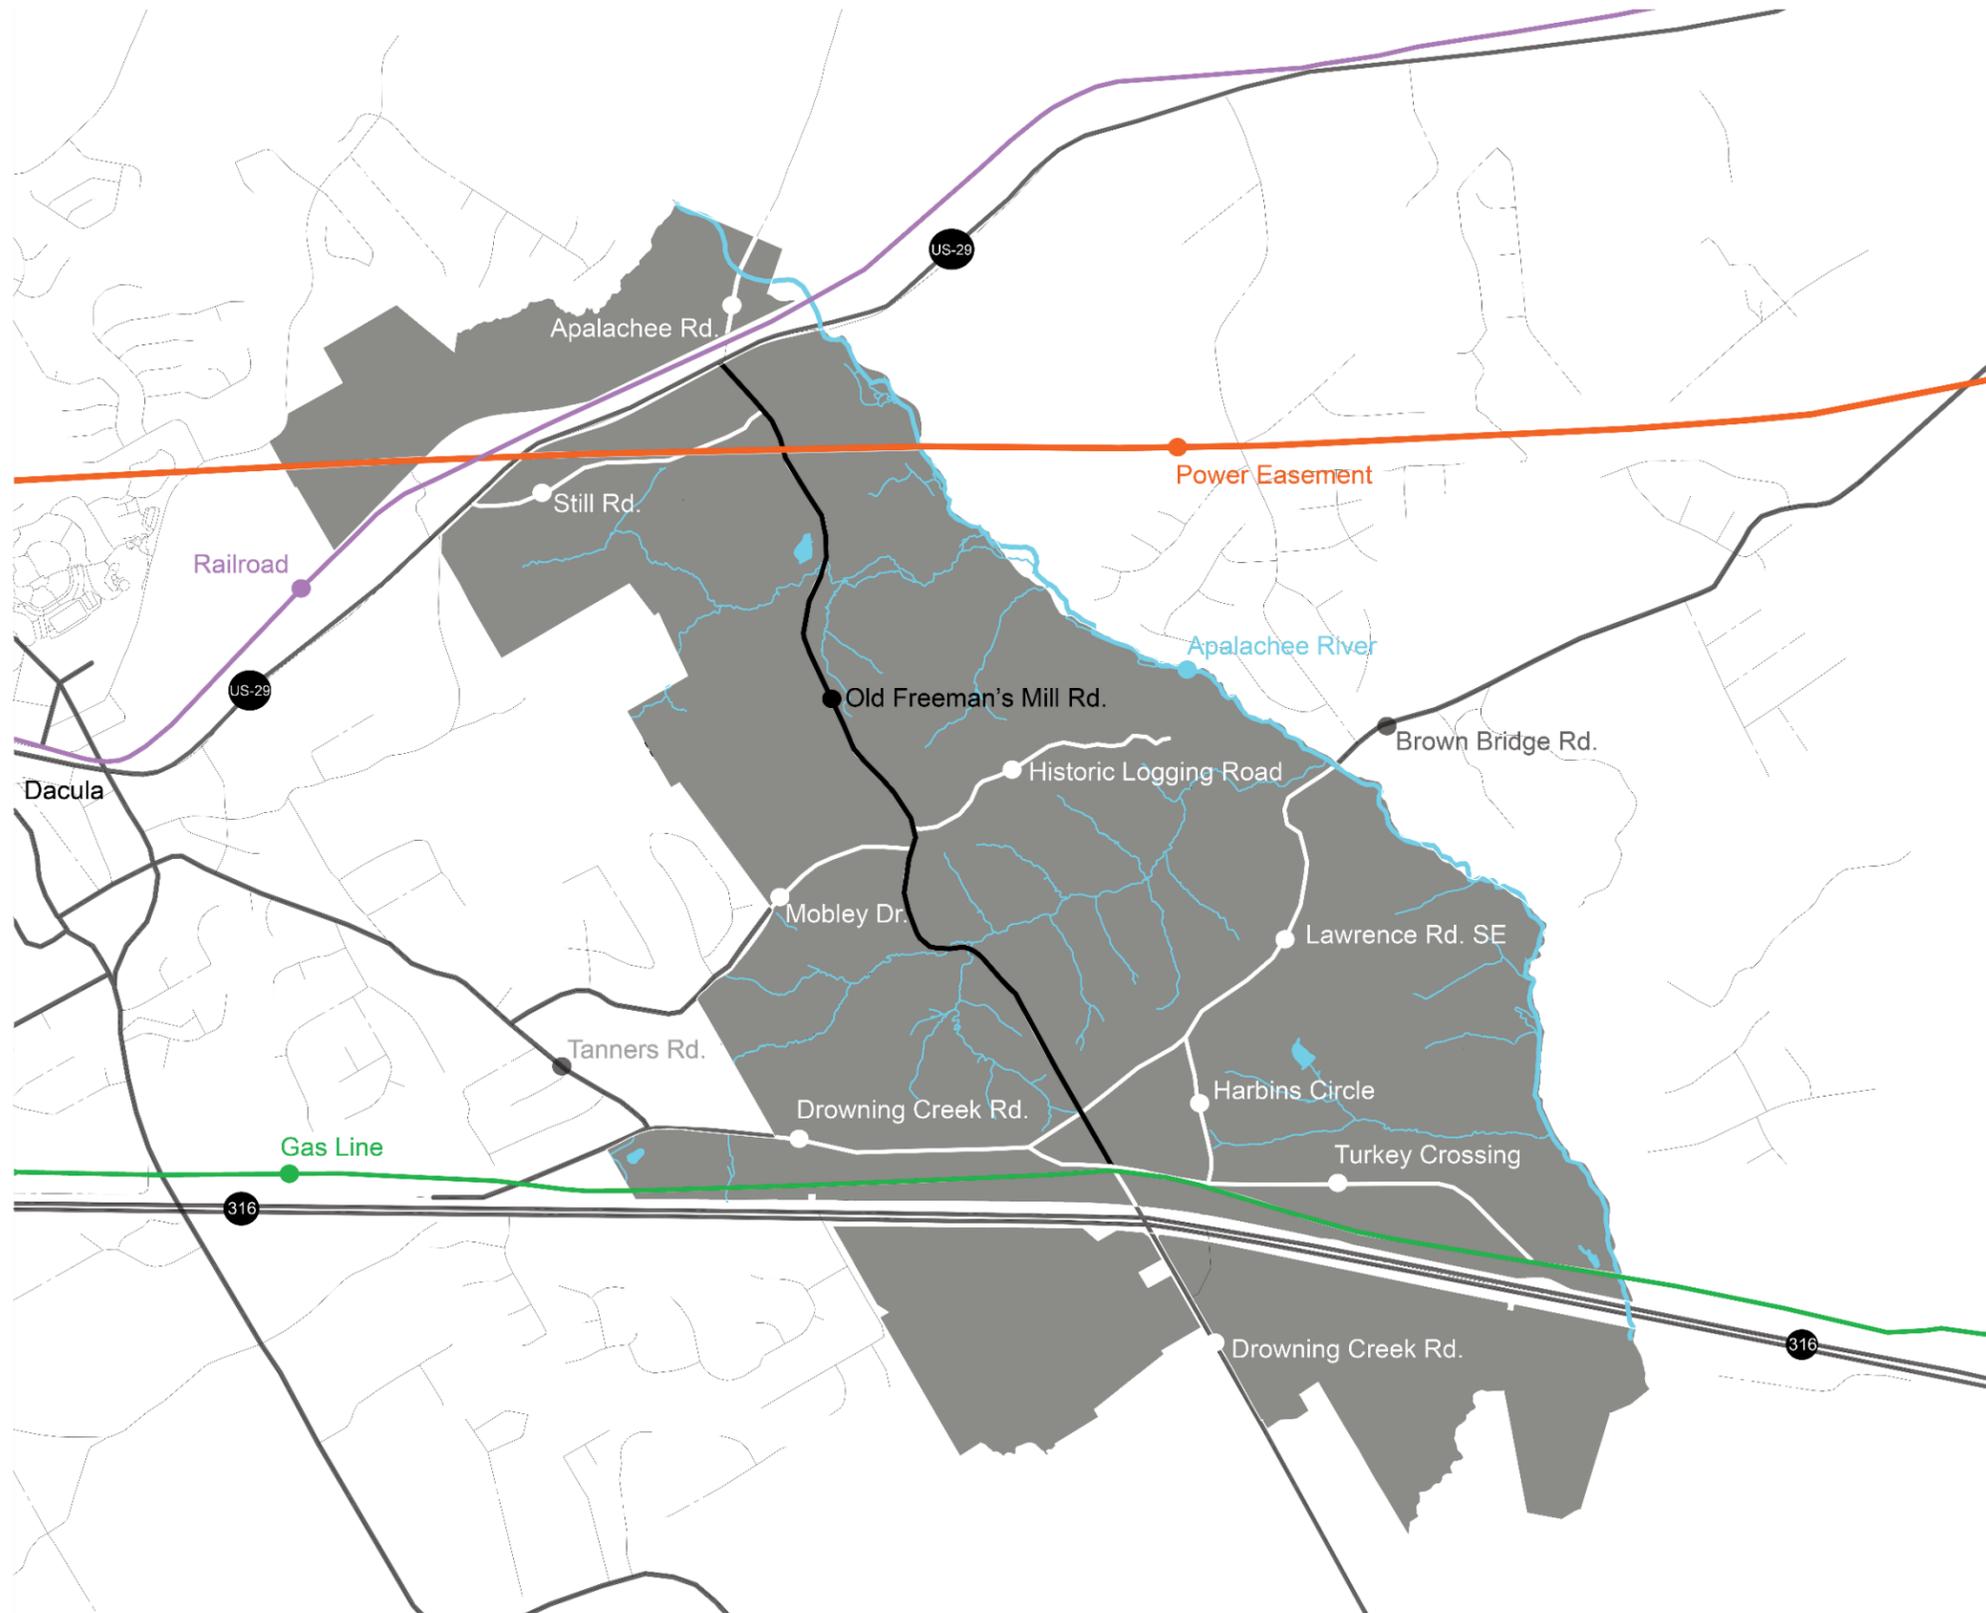
Rowen Circulation Map

The circulation map's purpose is to give the reader a better understanding of the location of major corridors that run through the property and give context to the surrounding geography of the area.

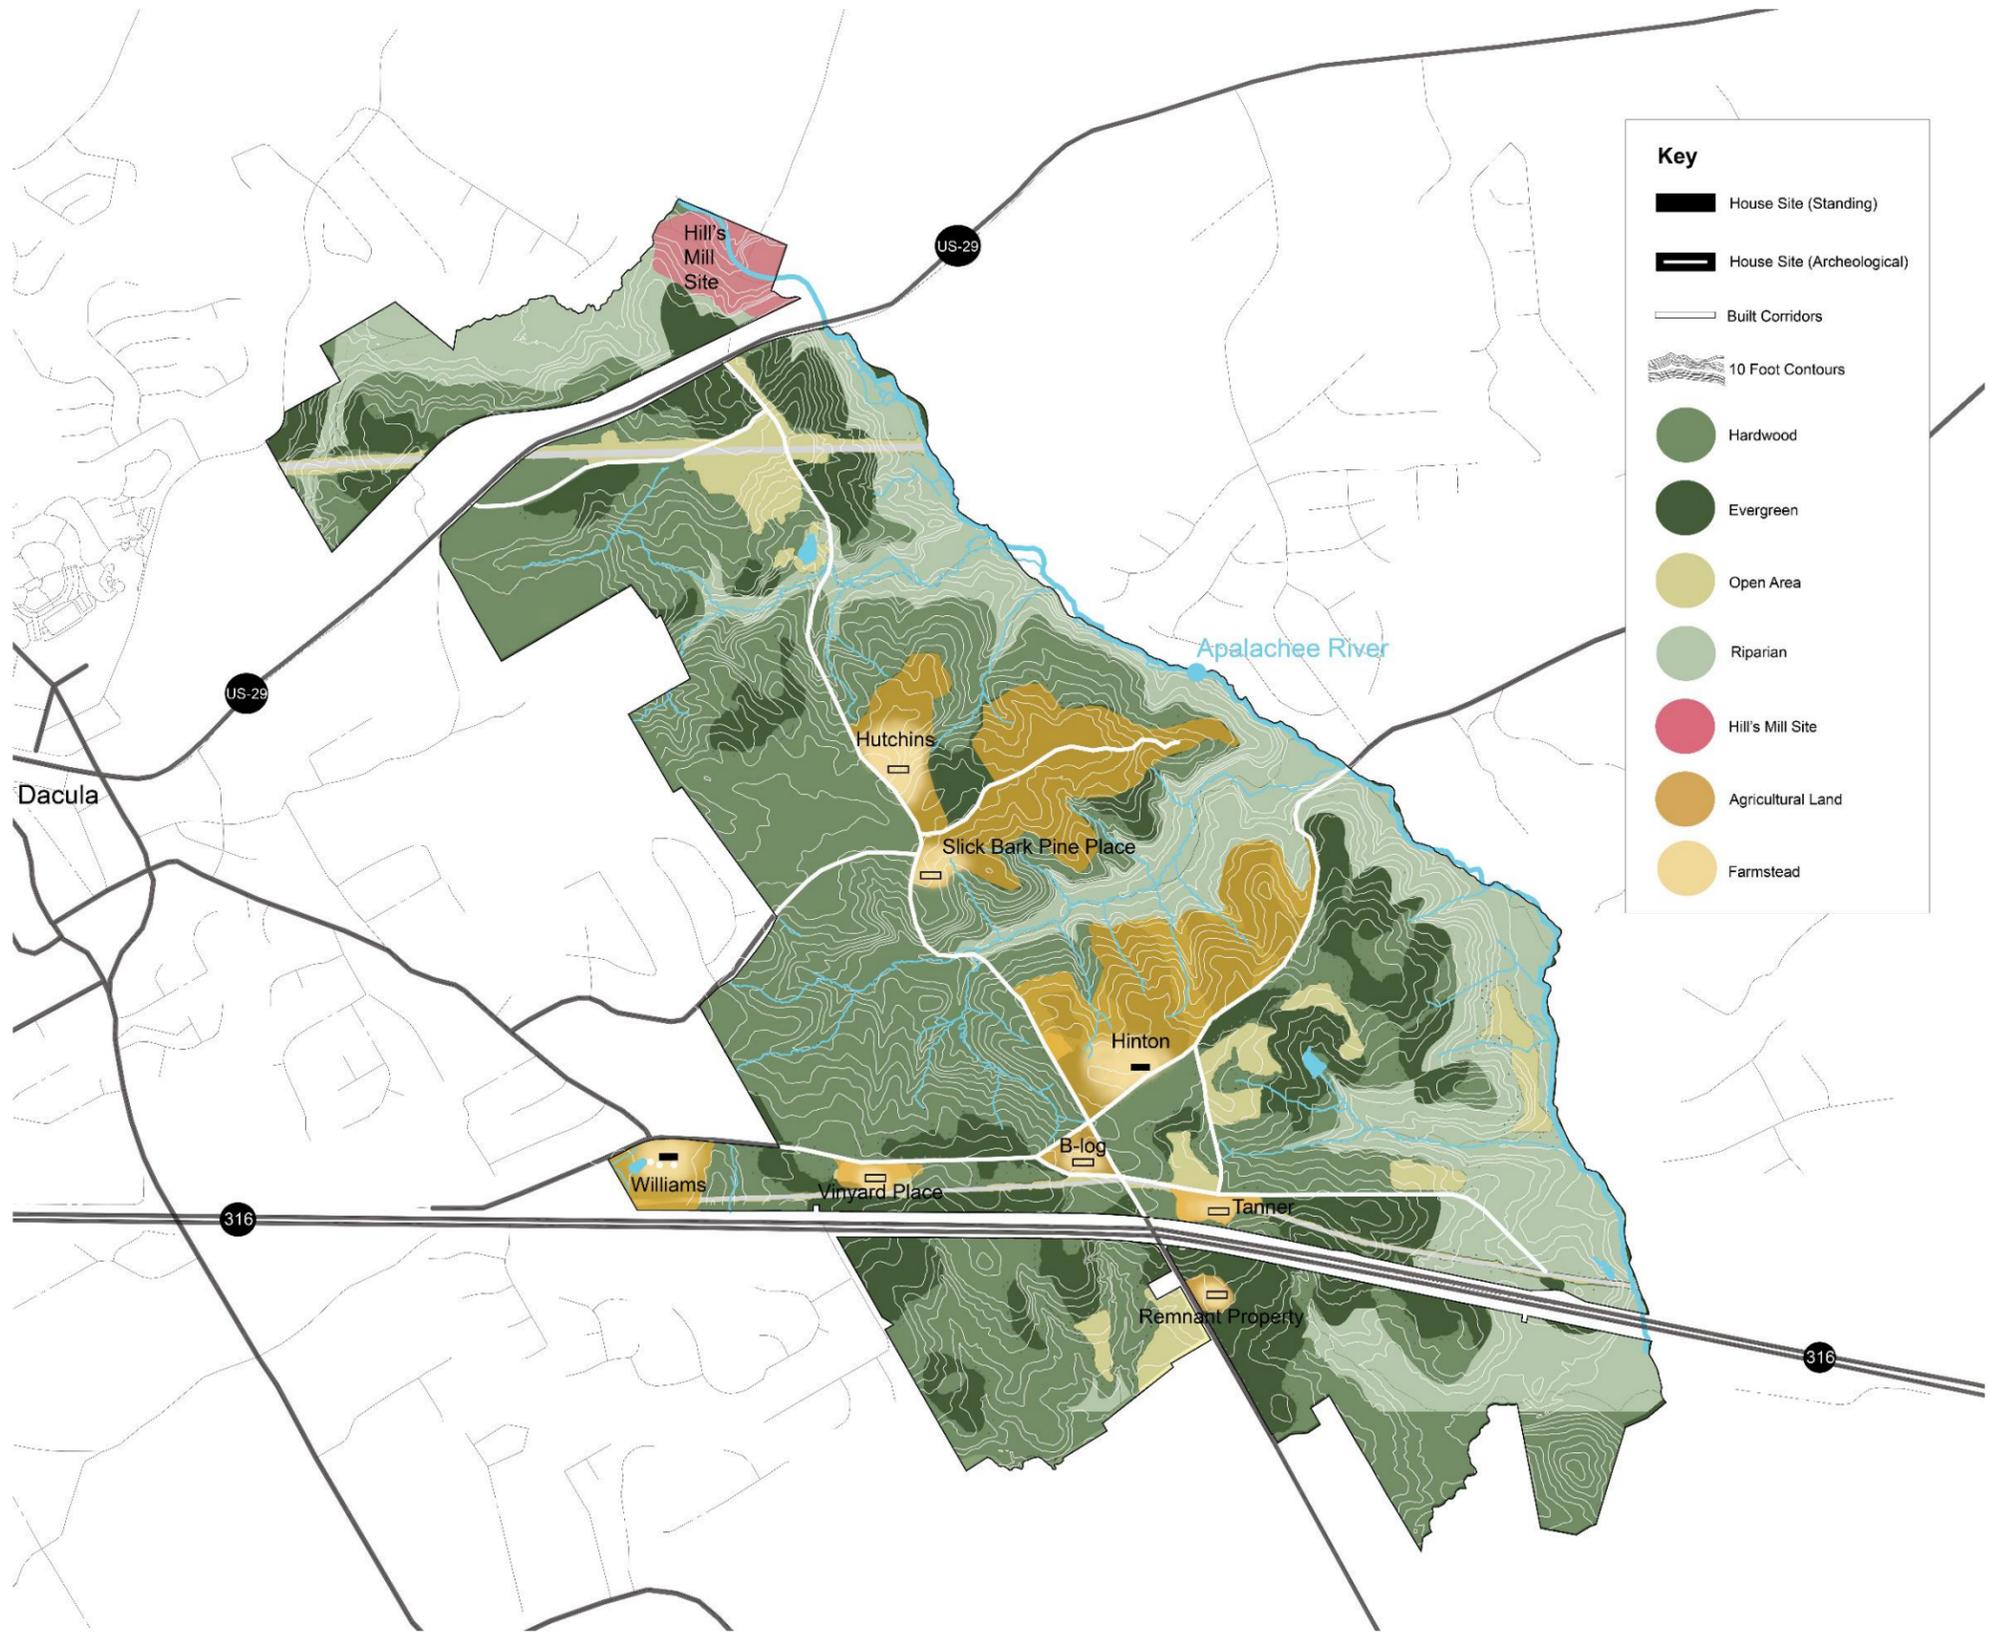
2019 - Homesite & Farmstead Map

This map expands on the existing conditions map by showing the farmsteads and homesites on the Rowen property. The black boxes show the house site, and the light orange highlights the area immediately surrounding the homesite. The darker orange areas show the extent of the farmstead surrounding the homesites.

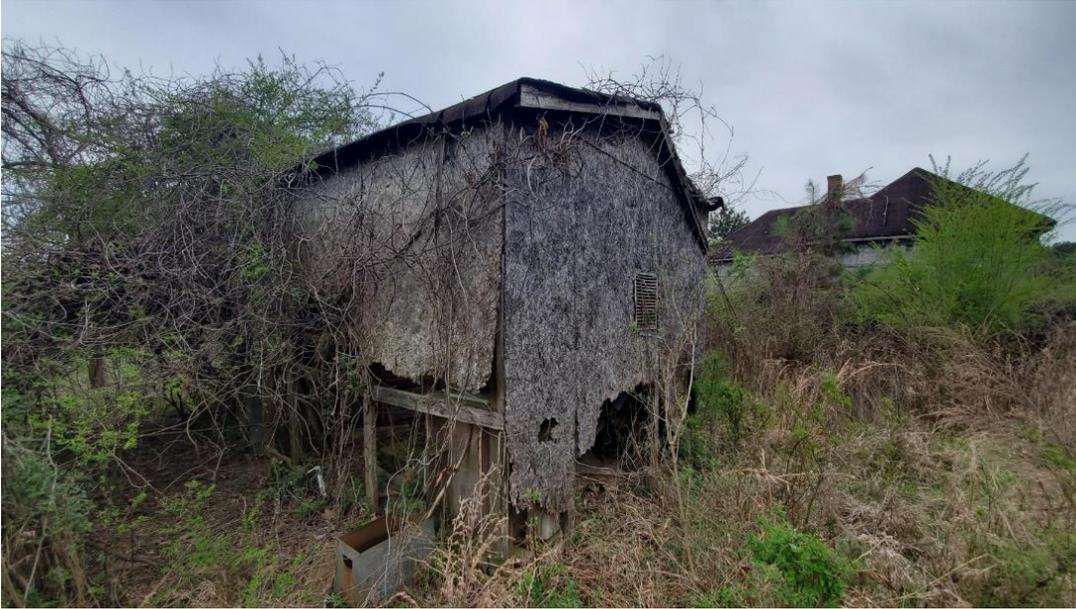
Water and shower shed in front of house. Plywood walls. Deteriorating condition.

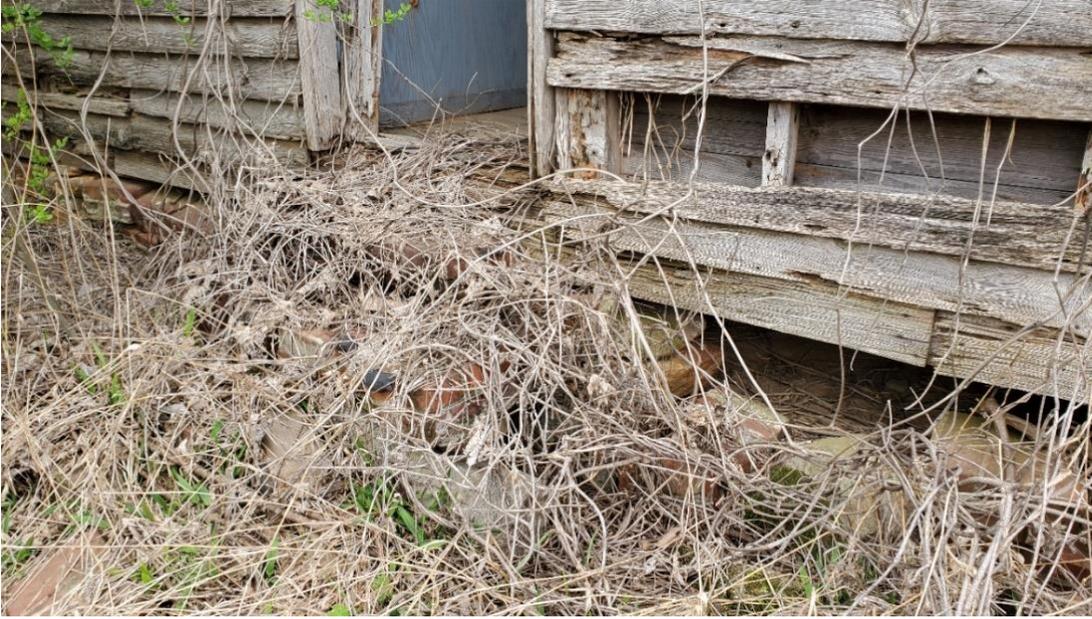
Close up of foundation on side of house, made of brick.

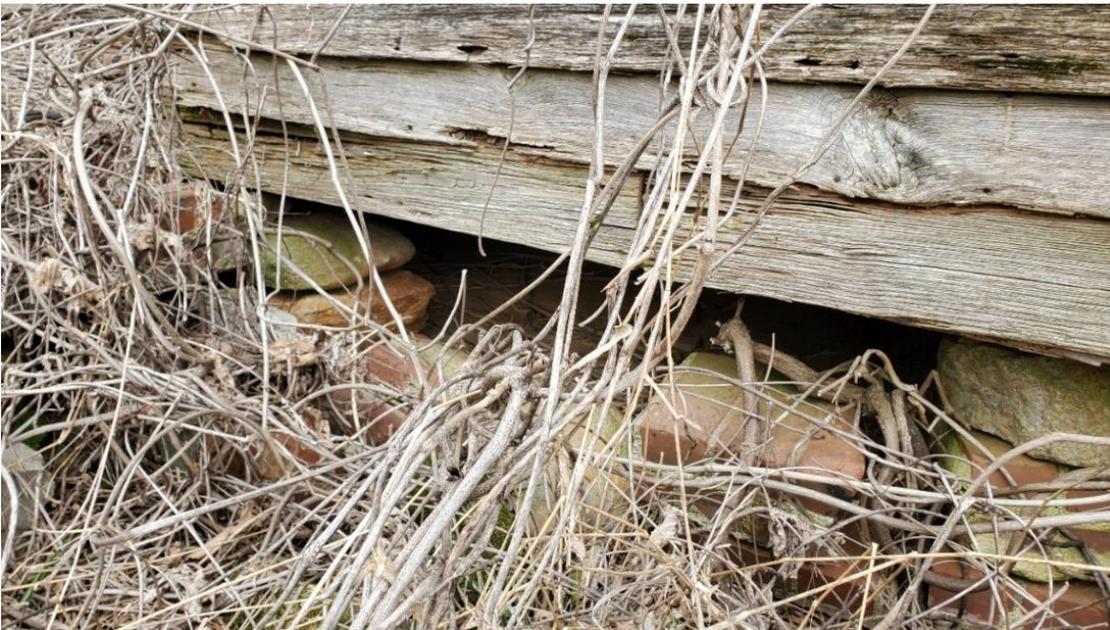
More brick and some stone as well in the foundation.
