**A History of the Rowen Tract and its Cultural Resources,
Gwinnett County, Georgia**

Mark Reinberger and Dan Nadenicek

University of Georgia, College of Environment and Design (CE+D)

November 2021

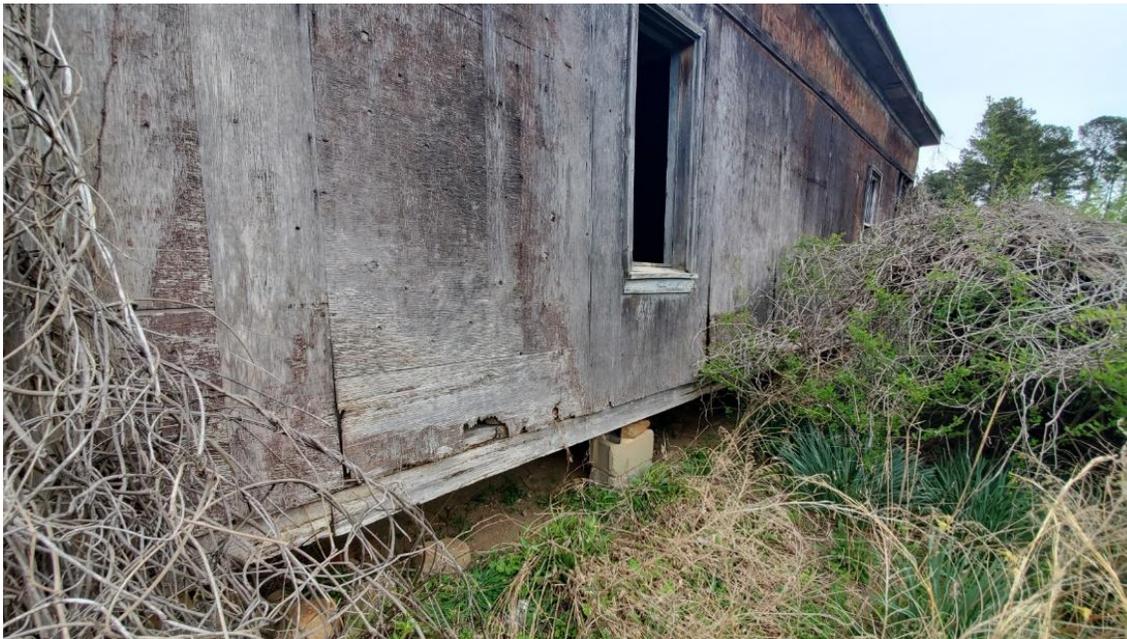
Cinderblock pier foundation replacements.

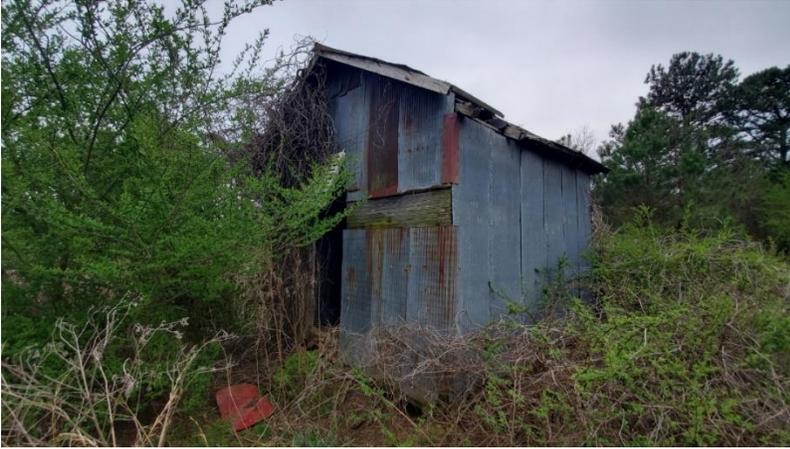
Wood framed agricultural shed, covered with sheet metal behind the house.

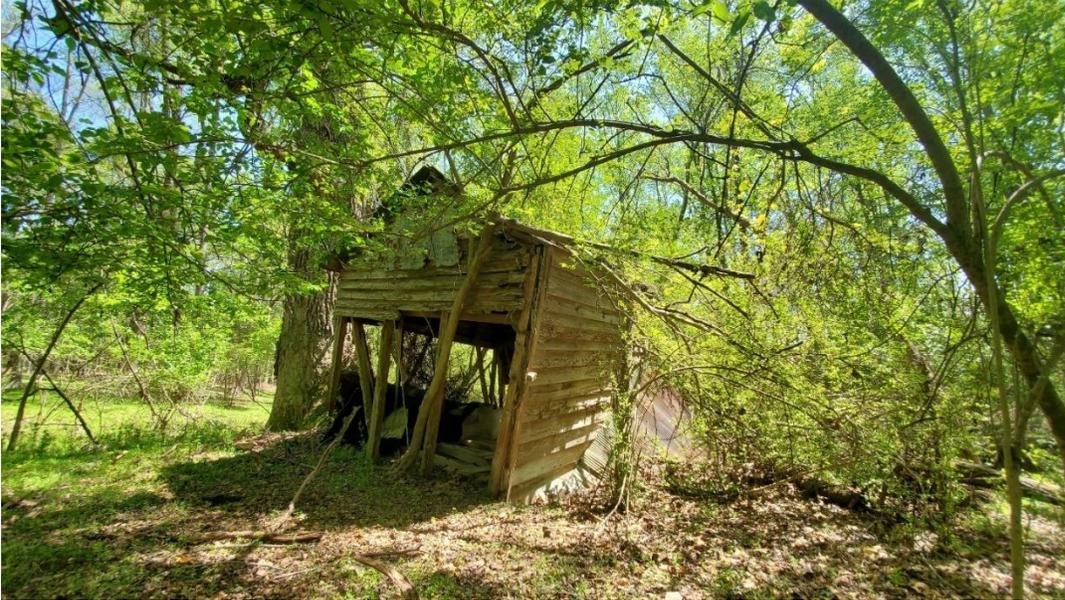
Rear half has shifted causing it to fall over.

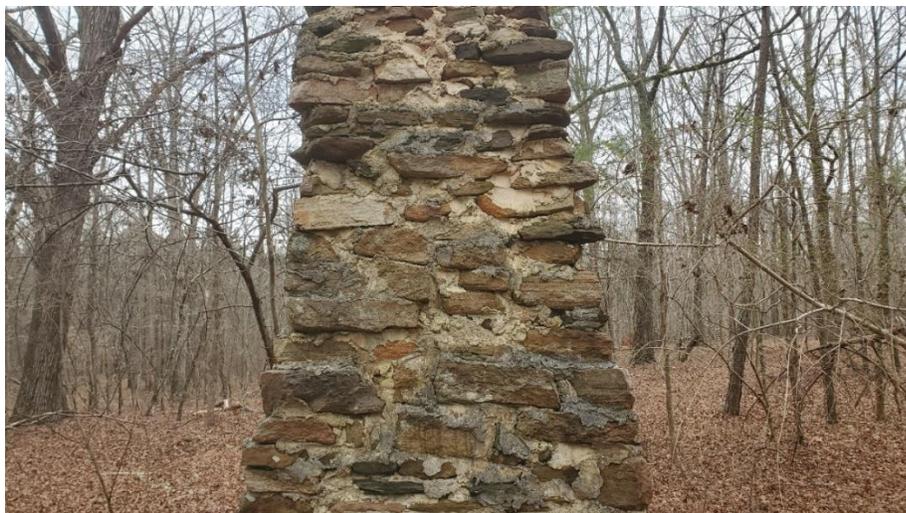
Detail of chimney stonework.

The Rowen Tract also contains two substantial above-ground ruins, namely, two standing chimneys: one at the Hinton Homeplace and one at the Slick Bark Pine House. Both are in fair to good condition and should stand many more years. Both should be inspected by a mason experienced with historic structures and spot repointed to insure continued resistance to the weather. Both should also be capped, perhaps with a piece of flagstone that will not be too visible or perhaps with copper, to exclude water from coming in the top. The Hinton chimney has a slight lean, which should be monitored periodically to see if it increases. If it does, corrective structural measures may be needed.

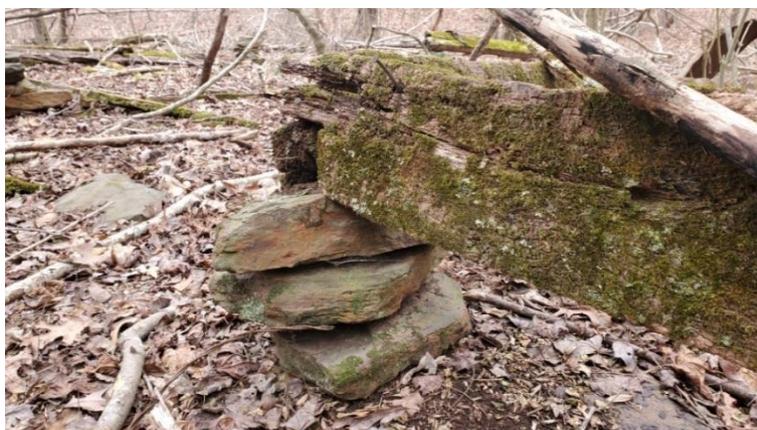
Close up picture of the stone pier foundation and wooden beam.

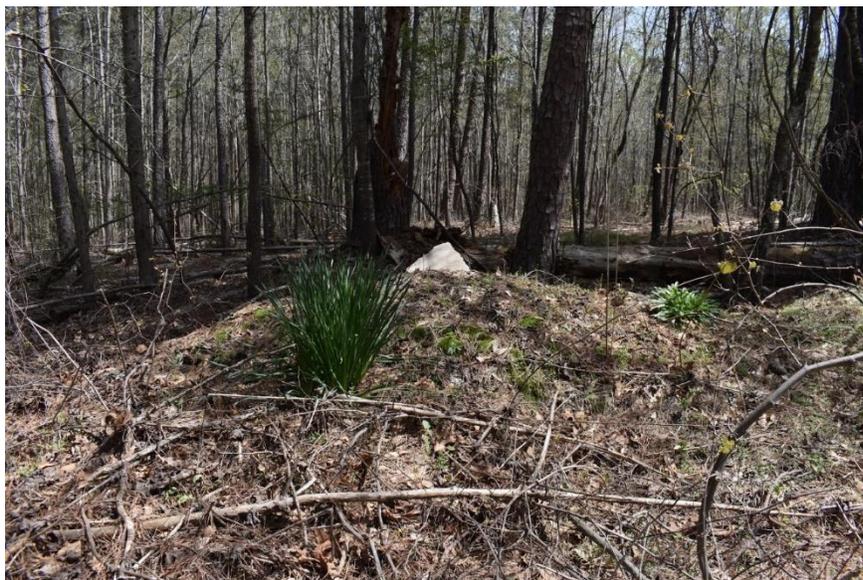
Rubble pile at Hutchins Place, probably the remains of the house's chimney

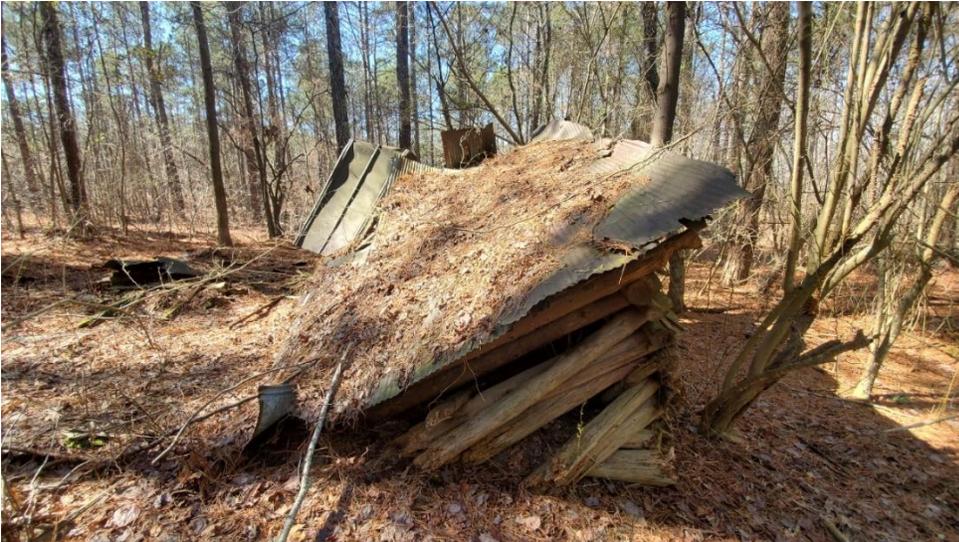
Current condition of barn/shed. Partially collapsed.
